# ANALYSIS OF THE INTERVENTION OF THE MILITARY FIREFIGHTERS TO EXTINGUISH THE FIRE PRODUCED AT THE HERCULES TUGBOAT

Ionut Voicu, Daniela-Elena Juganaru, Mariana Panaitescu, Fanel-Viorel Panaitescu

Department of Engineering Sciences in Mechanics and Environment, Electromechanics Faculty, Constanta Maritime University, Constanta, No. 104, Street Mircea cel Batran, Romania

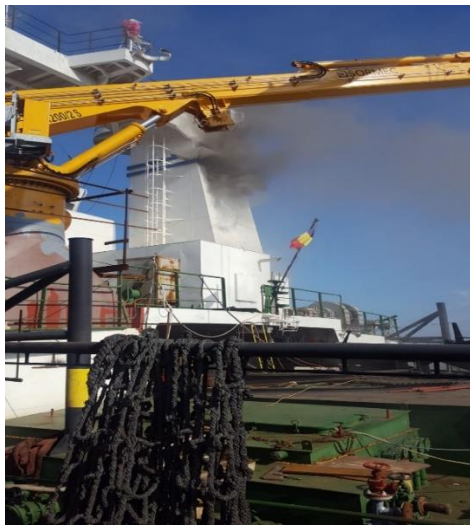
The National Emergency Call System 112, about the occurrence of a fire at a ship. The event took place at the Hercules Tugboat (figure 2)[2], owned by RASHLS, a tugboat that is being repaired/refurbished in berth no. 78, inside the Constanta harbor. The fire started from the engine room where they were large quantities of electrical equipment, and it burned smoldering, with large emissions of smoke, toxic gases and high temperature.

Fig. 2. Fire on Hercules tugboat. [2]

As the fire only occurred in the engine room, the material damage was minimal in the sense that the fire did not spread since the arrival of fire crews, resulting in the burning of electrical installations, panels and equipment, as well as paint on the walls. The walls of the engine room had just been painted.

Preliminary research conducted immediately after the fire and the statement of the personnel on board of the ship revealed that the fire occurred during the modernization works when a worker performing an autogenous welding work, in the engine room, perforated a wall of a tank fuel (diesel).

Through the hole, the fuel in the tank leaked and ignited on the wall, also igniting the paint with which it was freshly covered. Because the level of diesel in the tank was not much higher than the height of the hole, the amount of diesel leaking from the tank was minimal, but enough to set the engine room on fire.
