NON-TYPICAL DEFECTS ON SURFACES OF CERAMIC AND ROOF TILES: NATURE AND THE CAUSES

Zagorka Radojević, Anja Terzić, Miloš Vasić, Milica Arsenović

Institute for testing of materials, Bulevar vojvode Mišića 43, 11000 Belgrade, Serbia

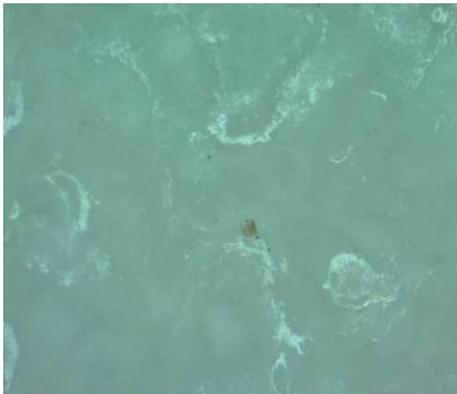
The sample which was taken from the fabric palette (Sample 1) contained empty pores and pores filled with certain black substance in the visible superficial

layers, i.e. glaze. According to the requirements of the Standards (SRPS EN 14411:2012; SRPS EN ISO 10545-2:2012), the appearance of the pores does not influence the quality of visible surface. The superficial layers/glaze of the samples peeled from the façade (Sample 2) contained the pores surrounded with the yellow „halo“ and filled with dark brown substance, pores filled with dark brown substance, and pores filled with black substance, and also empty pores. According to the requirements of the Standards (SRPS EN 14411:2012; SRPS EN ISO 10545-2:2012) the appearance of the pores filled with brown substance and yellow halo deteriorate the quality of a visible surface and such tiles are considered defected. The visible surface of the Sample 1 was examined via optical microscope. The surface is of white color, non-homogenous, husky/coarse and exhibiting pearly effulgence. The non-filled, round-shaped pores with mean diameter from 0.3 to 1 mm are present. Besides these voids, smaller irregularly shaped pores with mean diameter below 0.3 mm are also appearing. These pores contain black colored substance. Spots are occasionally present without presence of the voids. Fig. 1. presents an optical microscope microphotograph of the Sample 1 surface.

Fig. 1. Optical microphotograph of the Sample 1

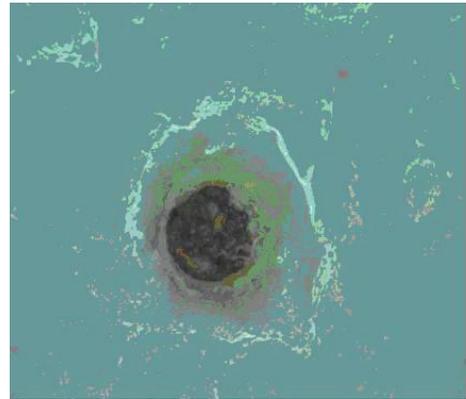
The visible surface of the Sample 2 was also examined via optical microscope. The analyzed defects were as follows: round pores filled with dark brown substance and circled by a yellow halo, round pores filled with dark brown and black substance, empty voids or pores with black substance. In the Fig. 2, an optical microscope microphotograph of Sample 2 surface is given.

Fig. 2. Optical microphotograph of the Sample 2

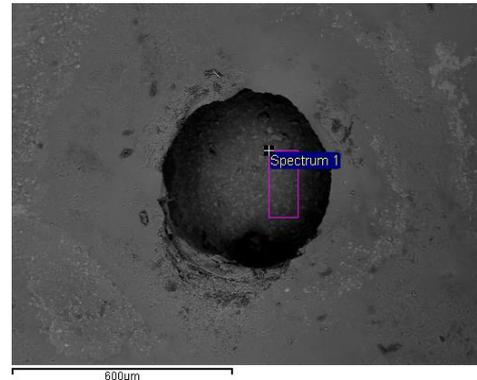
Fig. 3. SEM microphotograph of the Sample 1: empty pore

Defects that were present on the surface of the Sample 1 are of following types: empty pore or pore

filled with black substance. A characteristic circular pore is recorded via SEM and illustrated in Fig. 3. Microanalysis on of the empty pore highlighted the presence of the elements characteristic for the ceramic materials (glaze), [3, 5, 6]. One characteristic round empty pore filled with black substance is recorded by SEM and given in Fig. 4. EDS microanalysis of the fiber shaped inclusion pointed out on the dominant presence of the carbon.

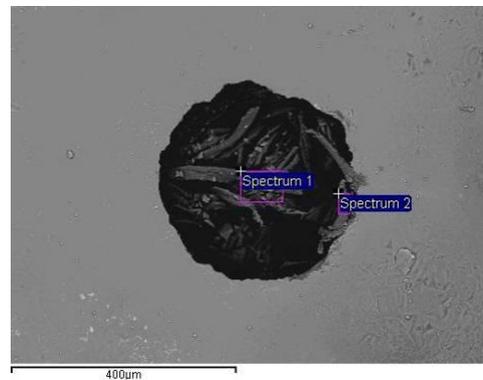
Fig. 4. SEM microphotograph of the Sample 1: pore with black substance

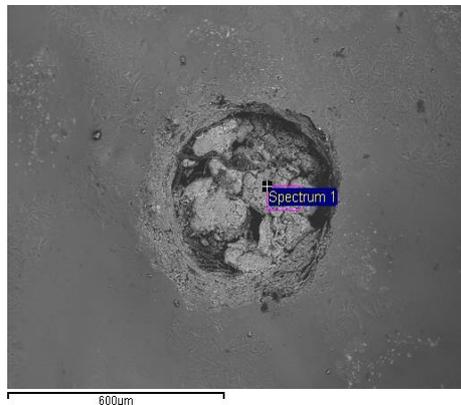
Fig. 5. SEM microphotograph of the Sample 2: round pore filled with dark brown substance and yellow halo

The SEM analysis of the Sample 2 discovered presence of following defect types: round pores were filled with dark-brown substance and surrounded by a yellow halo, another group of round pores were filled with dark brown and black substance, empty pores were present and pores filled with black substance. A defect with dark brown inclusion is presented in Fig. 5. EDS microanalysis of the dark brown matter highlighted the presence of Fe as main element, as well as O (besides Au which originates from the coating used for preparation of the sample). A defect with dark brown and black inclusion is illustrated in Fig. 6. EDS analysis of the middle part of the

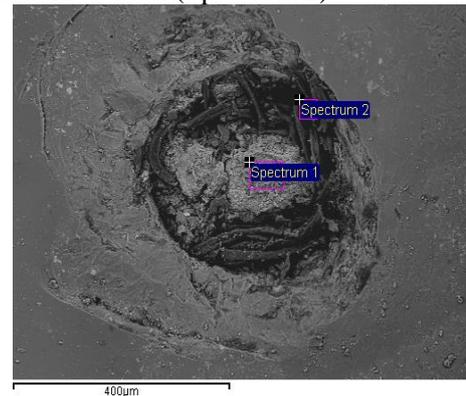
inclusion (Spectrum 1) pointed out to the presence of Fe, while the fibers near the pore wall mainly contained the carbon (Spectrum 2).

Fig. 6. SEM microphotograph of the Sample 2: round pore filled with dark brown and black substance

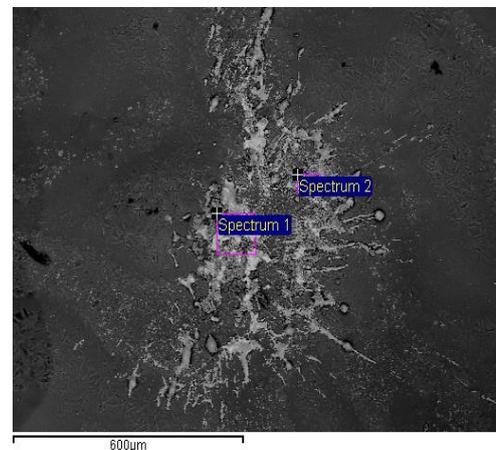
Fig. 7. SEM microphotograph of the superficial defects: dark brown formations of irregular shape

Based on the SEM recordings of the Sample 3 following defects were identified: formations of the irregularly shaped piles of dark brown substance sizing (0.4–0.8)mm, as well as the empty pores or pores filled with the dark substance. A characteristic dark brown substance of irregularly shaped formation, analyzed by SEM, is presented in Fig. 7. EDS microanalysis of this substance pointed out on the presence of Fe as main element as well as the O

(besides Au which originates from the coating used for preparation of the sample). SEM recordings of the piled substance showed that these formations are adhered to the tile surface. It was concluded that pores/voids in the glaze did not appear below described piles. In order to confirm that spark beams were not the cause of voids/pores appearance in the glaze, the analysis of the tile cross section has been performed. SEM microphotograph is given in Fig. 8. EDS microanalysis is provided in the Table 1. These microphotographs also confirm absence of the pore/void and that piled dark brown substance is located only on the surface of the tile.

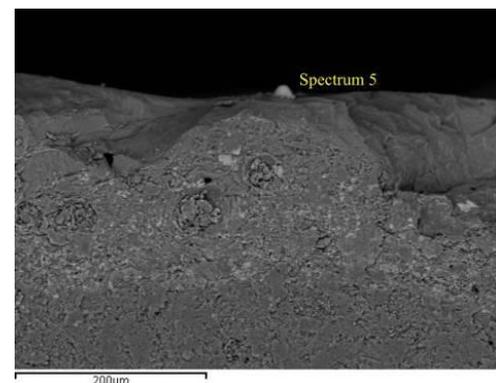
Fig. 8. SEM microphotograph of the cross-section of the tile with dark brown irregular-shaped formations

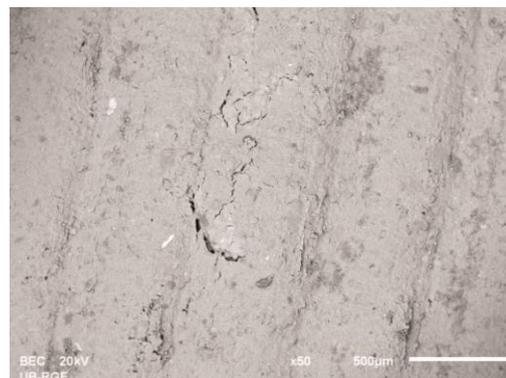
Inhomogeneities on the surface of roof tiles (C1.1 sample) were recorded via SEM at 50x magnification (Fig. 9.). EDS analysis is performed in certain spots. Fig. 10. shows microphotograph pattern of Sample C1.1, with four analyzed surfaces: three surfaces (spectrum 1, 2 and 3) encompass areas with inhomogeneous structure and irregular hairline, while the area designated as a spectrum 4 is homogeneous. EDS analysis results of those areas is given in Table 3. The results indicate an increased content of iron

(ranged from 8.46 % to 18.26 %) and manganese (up to 3.89%) in the field with inhomogeneous structure. Homogeneous structure area showed the iron content of 7.58 %, and manganese was not identified.

Fig. 9. SEM microphotograph of inhomogeneities on the surface of roof tiles (sample C1.1) at a magnification of 50x

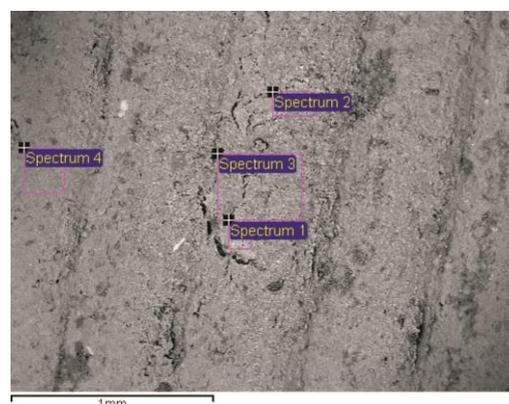
Fig. 10. SEM microphotograph of inhomogeneities on the surface of roof tiles (sample C1.1), areas that were analyzed by EDS

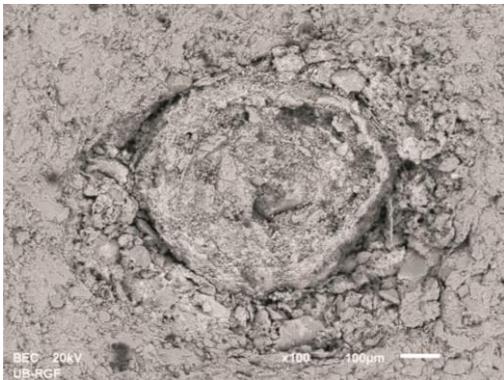
Sample C1.2 is also analyzed at higher magnification (100x) and SEM recording is given in Fig. 11. Inhomogeneity is of circular shape, with a diameter of about 1.5 mm. Within and around the grains there are visible microcracks, which give more porous structure in relation to the basic structure of the roof

The results of roof tiles surface analysis showed that the inhomogeneity is caused by ferruginous-manganese grains larger than 1 mm. In order to determine the nature of grains, the separation of sand fractions from starting raw material is performed. The separation is done by wet sieving using 63 micron sieves. The sieve residue is based on the grain size divided into fractions of 0.063 mm to 0.125 mm, from 0.125 mm to 0.25 mm, from 0.25 mm to 0.5 mm, from 0.5 mm to 1 mm, and of 1 to 4 mm. The sieve residues were analyzed by stereomicroscope.

Fig. 11. SEM microphotograph of inhomogeneities on the surface of roof tiles (sample C1.2) at a magnification of 100x

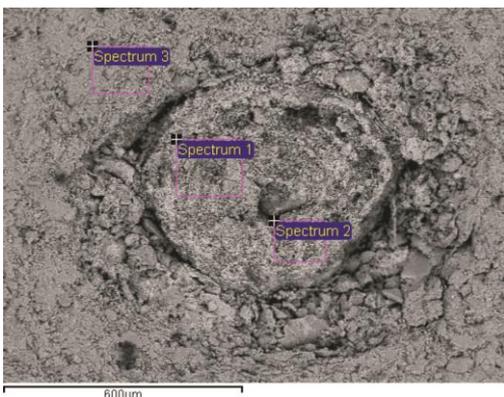
tile. In Fig. 12, microphotograph pattern of Sample C1.2 is given in three points. Areas that were analyzed (Spectrum 1 and 2) cover an area within the grain. Area designated as a Spectrum 3 contains no inhomogeneities. The results presented in Table 3 indicate an increased content of iron (from 11.14 % to 11.24 %) and manganese (8.72% to 12.95%) within the grain.

Fig. 12. SEM microphotograph of inhomogeneities on the surface of roof tiles (sample C1.2), areas that were analyzed by EDS

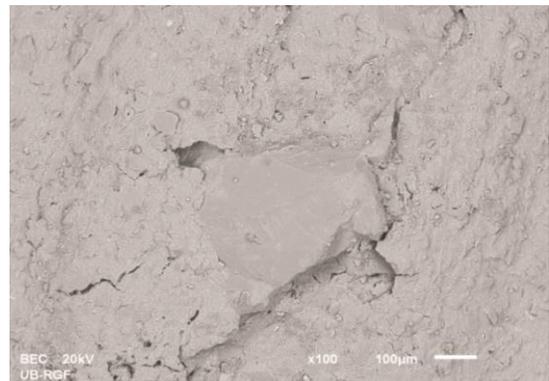
- The smallest fraction (0.125 - 0.063)mm is constructed of mica, quartz and metallic minerals. When iron minerals are concerned (magnetite, hematite, goethite and martite), there is the often case that Fe^{3+} is replaced with Mn^{3+} , or other metals. It should be noted that the main characteristics of magnetite, after which it differs from other similar minerals, are strong magnetism and high hardness (Mohs hardness 6) (Janjić and Ristić, 1989). In the process of pressing of roof tiles, larger grains of magnetite behave like quartz grains, they "rip the surface". However, in places of metallic grains, during firing of roof tiles, porous structure is obtained, which is not the case with quartz grains that remain compact. As an illustration, SEM micrograph of quartz grains on the surface of Sample C1.3 is given (Fig. 13).

Fig. 13. SEM microphotograph of inhomogeneities on the surface of tile that caused quartz grain (Sample C1.3)
