## MICROSTRUCTURE AND PROPERTIES OF LASER-WELDED BUTT JOINTS OF AlSi1MgMn ALUMINIUM ALLOY

**Abstract:** The process of autogenous laser welding of butt joints of aluminium alloy AlSi1MgMn plates with thickness of 3.0 mm was investigated. The Yb:YAG disk laser was used in the study. The aim was to determine the influence of the basic parameters of laser welding on the joint quality, fusion zone geometry, microhardness distribution across the butt joint, structure and microstructure of fusion zone (FZ) and heat affected zone (HAZ) was studied and determined. The chemical composition of the base metal was determined by spark emission spectroscopy, while the phase constituents were determined by XRD analysis. Results of the study have shown that the geometry of welds is proper without excessive imperfections. No voids were found in the FZ. However, weld face of the joints are slightly convex, while the roots are slightly concave. Microscopic observations showed no discontinuities in the fusion zone of the welds. A significant decrease in hardness in the FZ was observed. The hardness in the FZ of the test joints is approx. 67÷70 HV<sub>0.1</sub>. The fracture of the samples during tens

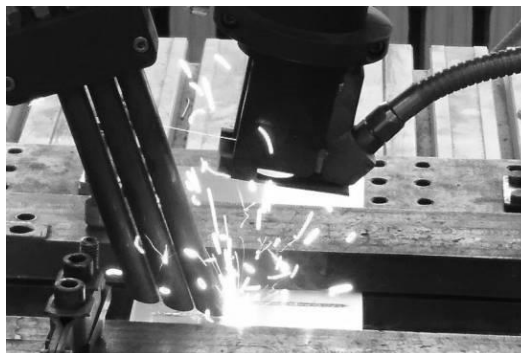
Fig. 1. A view of bead-on-plate laser welding of aluminium alloy AlSi1MgMn by the TruDisk 3302 laser (head tilted at 12°)

Tests of welding were conducted by means of a fully automated and programmable stand with the solid state disk laser TruDisk 3302. The maximum output power of the laser was 3.3 kW, while the laser beam divergence angle 8.0 mm·mrad. At the applied configuration of the optics and the focusing head, the focal diameter was 200 µm, Figure 1.

Prior to welding tests, the oxide layer was brushed and removed from the surface by means of a brass wire brush, and the surface of the sheet was degreased with 96% ethyl alcohol. Samples were clamped and stiffened mechanically. The flow of high purity argon (99.999%) by a cylindrical nozzle 8.0 mm in diameter was applied for protection of the weld region. The flow rate of argon was approx. 12÷15 l/min. Since the reflection of the laser radiation from the aluminum surface is high, the laser head was tilted at an angle of 12 degrees to avoid the risk of damage to the optics, Figure 1. The laser beam was focused on the top surface of the sheets to be welded.

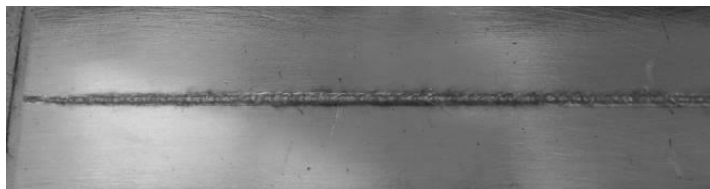
Fig. 2. A view of a representative test joints of AlSi1MgMn 3.0 mm thick and 200 mm long sheets made at the laser beam power of 2.0 kW and welding speed 1.5 m/min (energy input 80 J/mm)

In the first step, visual examinations VT and an initial quality assessment of the test joints were carried out. It was found that for each joint, a lack of full penetration was found in the initial length of about 15 to 20 mm. The width of the weld face increases gradually over this length until it reaches a stable value for the remaining length of the weld, as can be seen in Fig. 2. This phenomenon is caused by the stabilization of thermal conditions in the initial phase. This is mainly because of a high thermal conductivity of aluminium and also due to high reflectivity of the laser radiation. As a result, increase of the absorption and heat energy transferred to the substrate material is gradual (absorption depends also on the temperature). On the other hand, there is usually a small crater at the end of the weld, caused by a sudden shutdown of the laser beam or the laser beam exiting the joint area. At the same time, the properties of aluminium in the liquid state make the tendency to create craters and shrinkage cavities higher compared to steel. This is due to the physical properties, but also the casting shrinkage of aluminium at the level of approx. 6%.

The problems described above can be solved by using a programmable change of welding parameters, including laser beam power or applying run-on and run-off tabs for starting and ending the process. However, such solution is an additional difficulty in the automated process. As can be seen on the representative joint, the surface of the weld face is not even and not smooth. There are irregular and uneven scales on the weld face. Such phenomenon occurs usually at high welding speed.

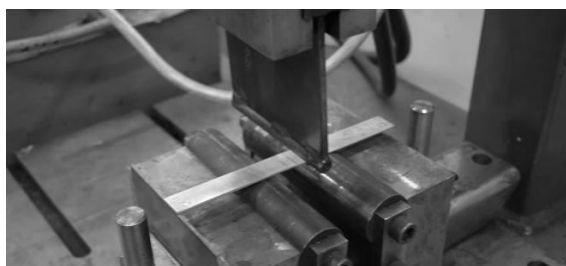
Fig. 3. A view of the device for technological bending test of 3.0 mm thick butt joints of AlSi1MgMn and its configuration

The mechanical properties of the test joints were determined using a technological bending test and a static tensile test. The configuration (arrangement) of the device for bending tests is shown in Figure 3.

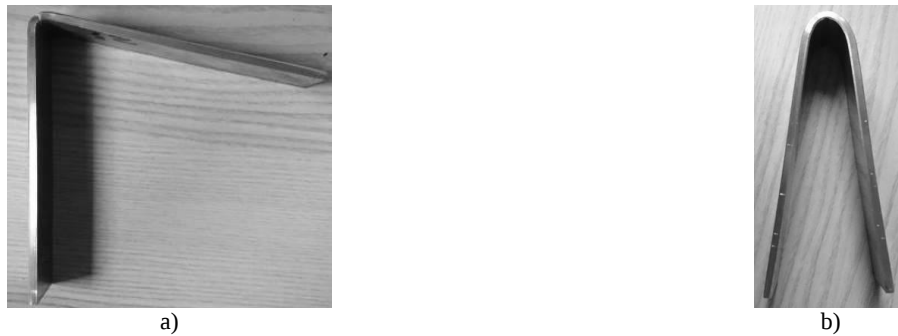
Fig. 4. A view of the samples of the butt test joint of AlSi1MgMn 3.0 mm thick sheets made at the energy input of 80 J/mm; a) after weld face bending (crack at approx. 100°), b) after root bending (full angle 180°)

Figure 4 shows representative samples of just one test joint after bending tests. However, in the case of all tested joints, the results were convergent. Each sample tested under bending from the root side obtained positive results of the bending angle of 180°. In turn, the samples bent from the weld face side cracked at the bend angle 90÷100°. Such a result may suggest that defects accumulate near the weld face or there are discontinuities in this weld region.
