PRACTICAL RESULTS OF PREDICTIVE MAINTENANCE PROCEDURE INTRODUCTION IN ROMANIAN PAPER INDUSTRY

Ancuta Costea¹, Olimpia Ros¹ & Csaba Gyenge¹

Abstract: This paper presents applicative studies related to the implementation of the supervisor system and predictive maintenance in the paper industry. Bank data content is presented regarding the unexpected functioning interruptions and reconditioning technologies. The constructive and technological aspects regarding the maintenance of this unit are presented using one case study, proving the real advantages of this concept as compared to the classical concept of maintenance.

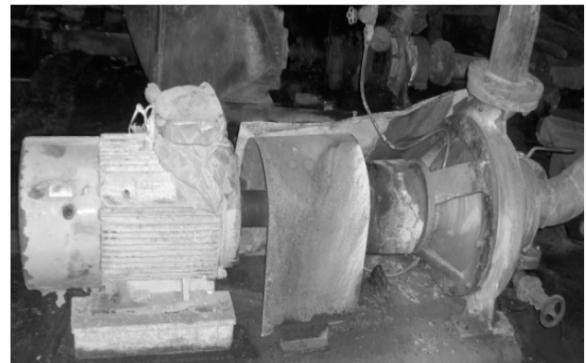
The black lye pump, illustrated in figure 5, is equipped with NU 312ECP bearing, on the rotor side, and a tow 6313NR bearing on the electric engine side (Fulop et al., 2008).

Fig.5. Black lye pump

The breake down of the pump was caused mainly because of the deterioration of the 6313 NR bearing that is placed on the electric engine side. Possible causes of the bearing deterioration were identified, as following:

- the radial roller bearing 6313 NR was replaced with two radial-axial roller bearings assembled in set from 7313 BECBP series;
- the dynamic balancing of the rotor was made for a relative velocity of 1500 rot/min;
- the soft consolidation between the case of the pump and its axle was replaced with a mechanical consolidation. For this purpose, the wear sleeve was taken out and the axle of the pump was modified in order to realize the optimal assembly of the mechanical consolidation;
- the manufacturing of the base plate of the pump has been made in one fixing direction.

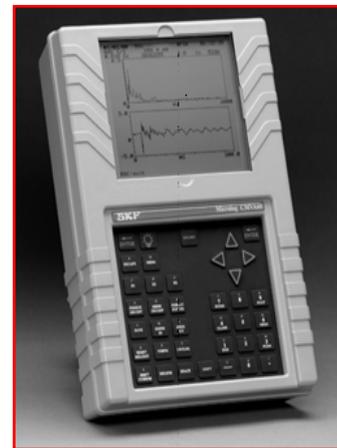
For this purpose, we have used the Microlog CMVA60, (figure 6), and Martin-Condition Detector device, in order to measure the period of the vibrations in the following directions: H – horizontal, V – vertical and A – axial.

Fig. 6. Microlog CMVA60
